How Much Is Too Much

The following was taken from an existing condition monitoring account at Perot Systems in Dallas Texas.

The equipment was one of three 1100 ton built up BAC Prichard cooling tower cells with Amarillo model 135 double reduction gear reducers and 60" jackshafts. Permanent accelerometers were mounted on gear reducers h e to accessibility. Baseline data was taken and frequencies inputted into database. An outside contractor had replaced the hot deck section and some structural supports. Several weeks later a considerable in overall velocity at the gearbox in the axial direction was noticed. An increase from .24in/sec to .40in/sec. Velocity spectrum data showed 1 X motor input frequency at .38in/sec. Phase data was taken and showed 180° shift across jackshaft in both the axial and radial positions. Misalignment as well as some couple unbalance were apparent. Laser alignment was performed and motor feet repined. A couple balance was then done and overall dropped to .22in/sec. At this point our phase data was unstable and erratic. New collection route was taken and a current alarm noted. Our high frequency trend and envelope also went into alarm from .4gse to 5.9gse

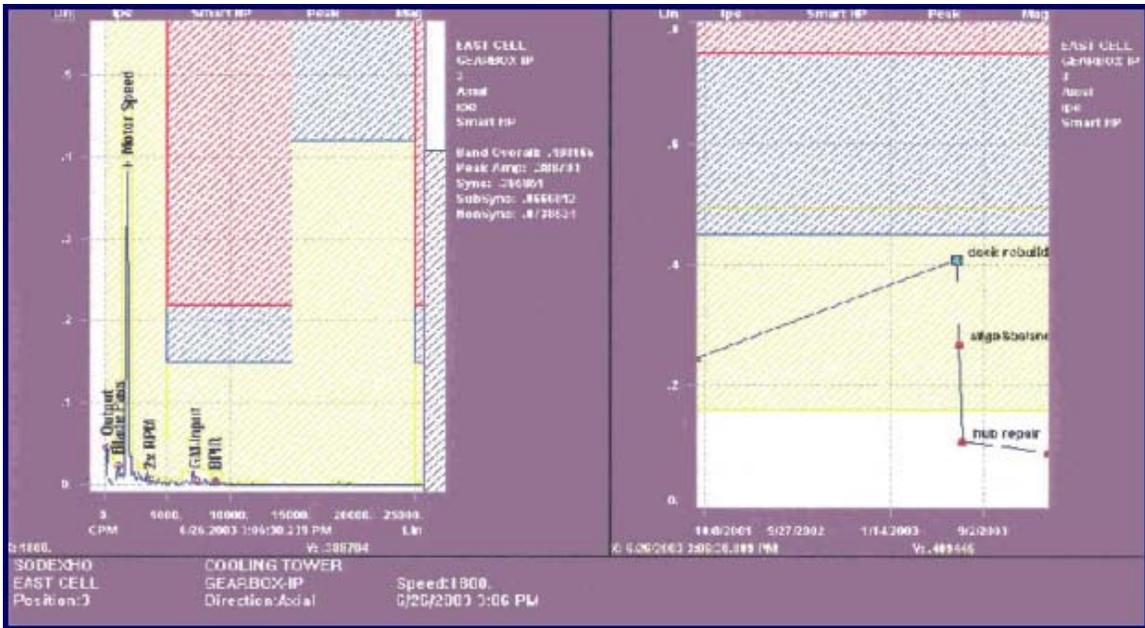
Magnitude trend shows velocity increase from .2in/sec. to .408in/sec. after deck and structure replacement. Spectrum shows input speed dominant from .22in/sec. to .38in/sec.

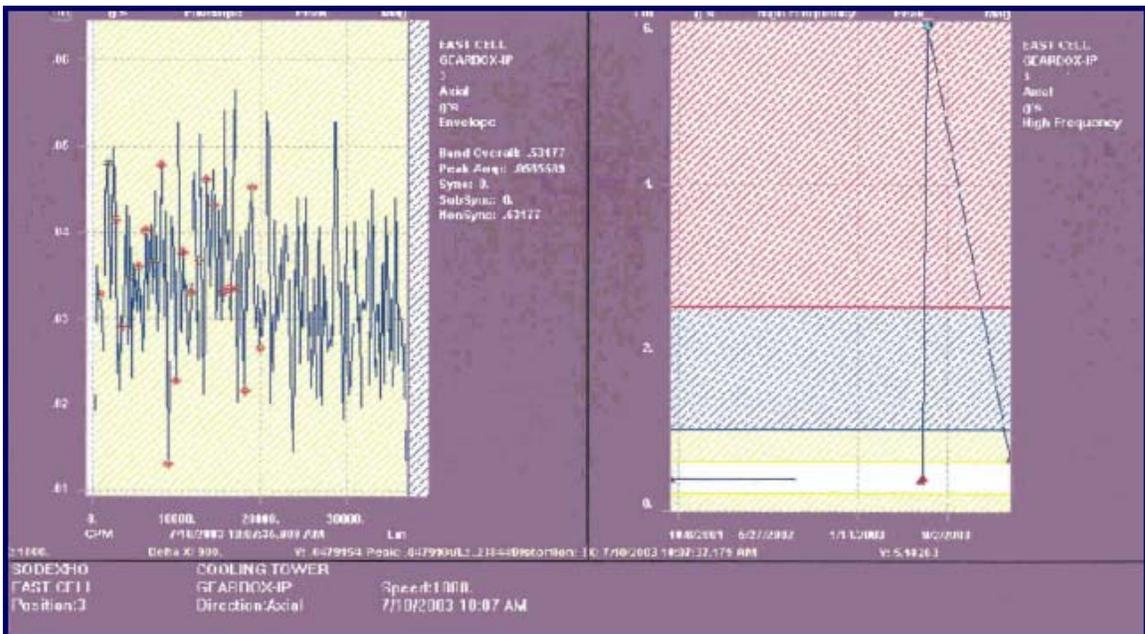
High frequency trend showed increase from .3g to 5.9g and triggered alarm
 Envelope spectrum showed input speed and harmonic impacts as well as 1/2X sub harmonics.

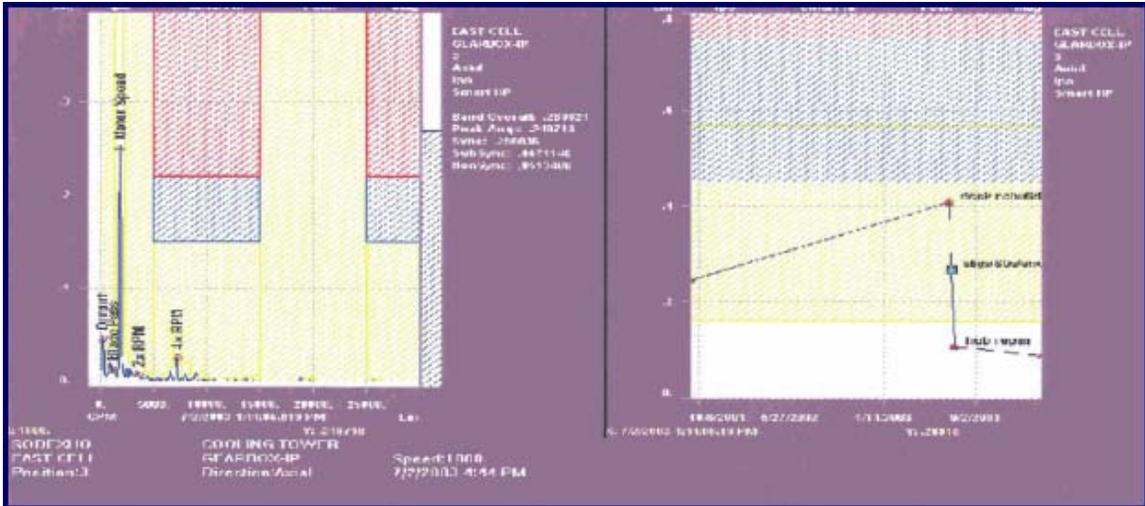
After laser alignment and couple balance dropped from .4in/sec. to .26in/sec. overall. Input speed dominant at .24in/sec. from .38in/sec. Spectrum showing input harmonics increased. Looseness present.

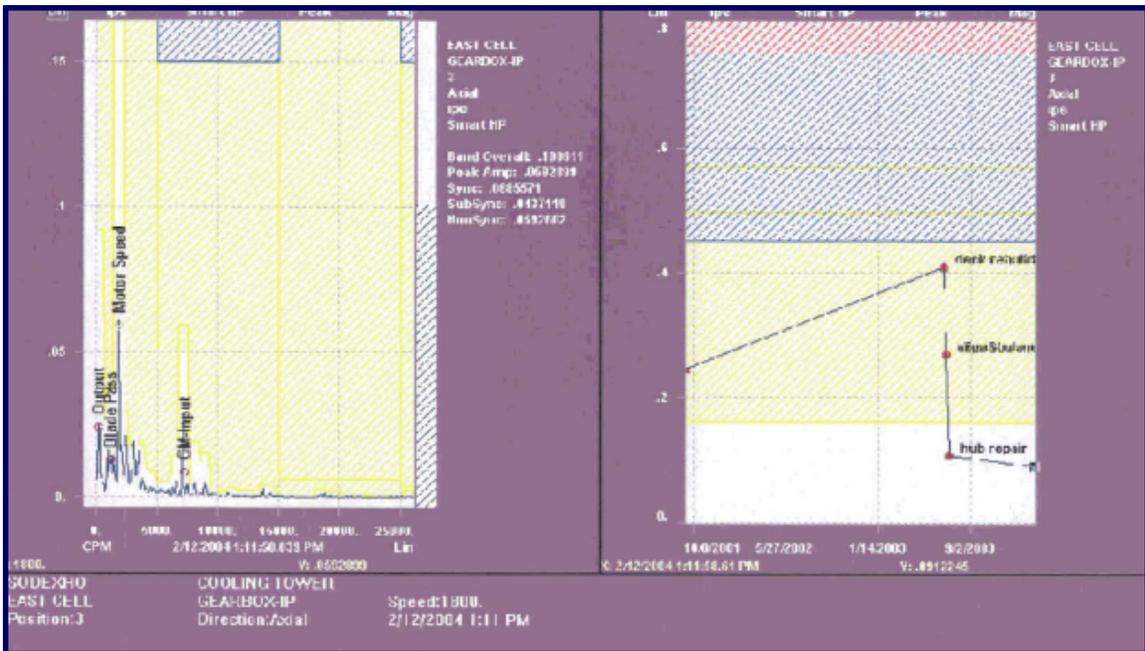
After shaft yoke repair velocity magnitude down to .09in/sec. Spectrum shows input speed down from .38in/sec. to .05in/sec. GM-Input appears after close coinciding 4X input harmonic went down.

The yoke was re-machined to a machine fit and bushing retainers installed. Jackshaft was then trim balanced to standard and new collection taken. Final data showed velocity readings down to .09in/sec. overall with input frequency at .06in/sec. High frequency data was down out of alarm at .6gse.
