Thermal Problem Detail Report

Site: Russell Reeves Home

Location: Guest Room

Equipment: South Wall

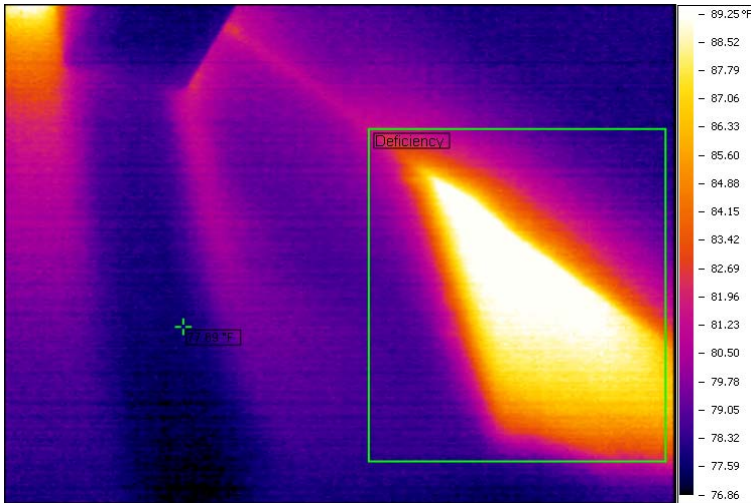
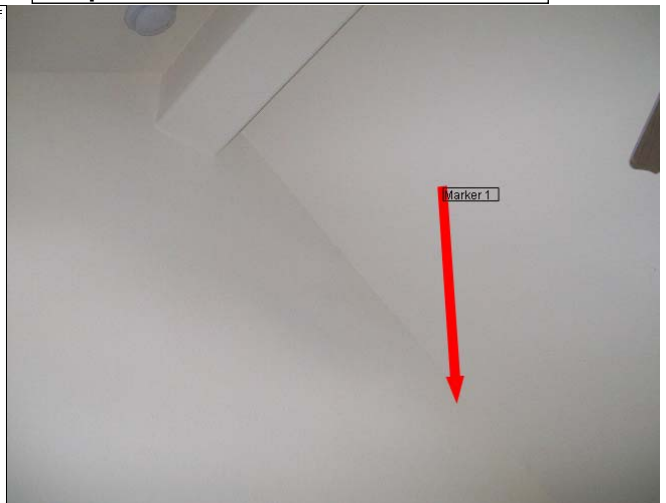
Inspection#: 1	Prob#: 13
Prob Date&Time: 08/24/2008 17:52	
Indirect Temp.Measurement: No	
Component Temp.: 91.7@N/A	
Reference Temp.: 77.7@N/A	
Temp.Rise: 14.0@N/A

Component: South wall.

Probable Cause: Insulation Deficient. Note the bright shaded area near the top of the wall.

Recommendation: Consider upgrading this area with additional insulation, in order to improve efficiency. I recommend an insulation contractor evaluate and estimate costs of installing insulation in this area.
