## Thermal Problem Detail Report

**Site:** Ennis Extruded Products

**Location:** MCC 5

**Equipment:** Section D

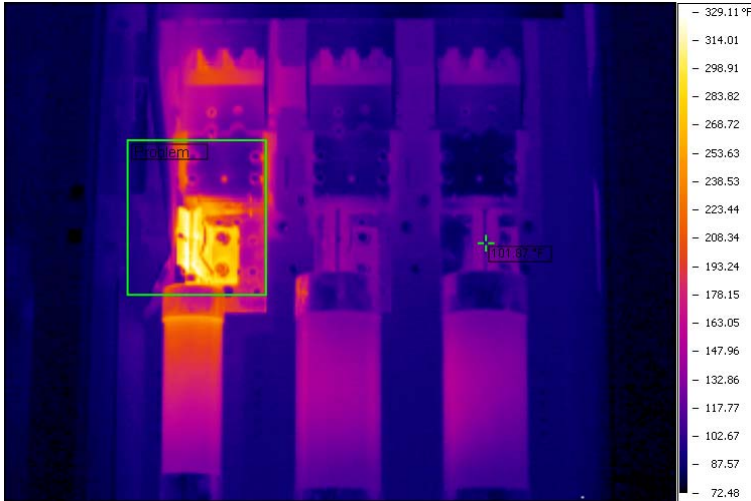
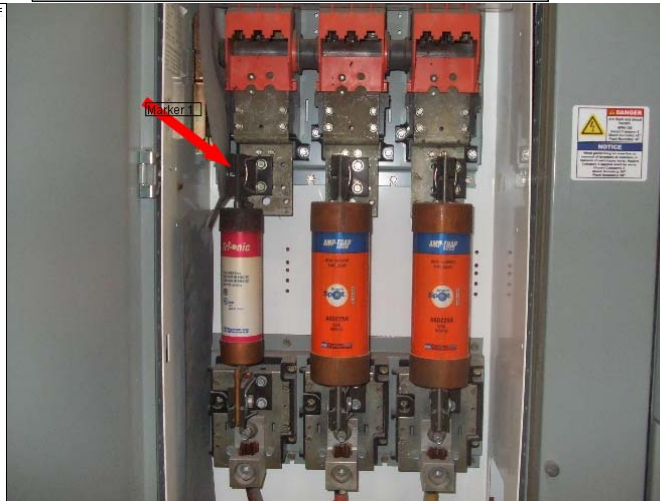
**Component:** Section D1 Quincy East - A Phase Fuse Clip

| <b>Component Temp.:</b> 329.7@78.4% | |
| <b>Reference Temp.:</b> 101.9@78.4% | |
| <b>Temp.Rise:</b> 227.8@78.4% | |

**Probable Cause:** Loose fuse clip on the 'A' phase line side. Also, mismatched fuses.

**Recommendation:** Clean and tighten fuse clip. Replace as necessary.
