## Roof Problem Details Report

**Site:** Campfire USA

**Equipment:** Old Building - North End

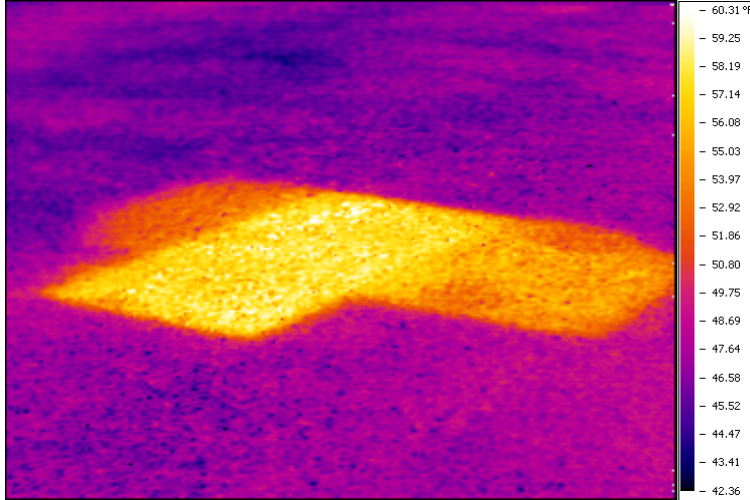
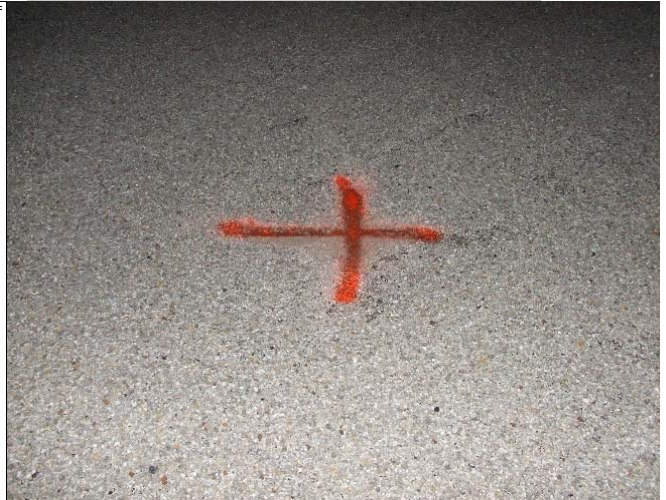
**Component:** Northwest Side - North side of Old building

**Asset ID:** **Condition:** Inter-ply Moisture

**Note:** Possible Patch.

**Probable Cause:** Location showed possible moisture penetration.

**Recommendation:** Confirm with moisture probe and/or core sample.

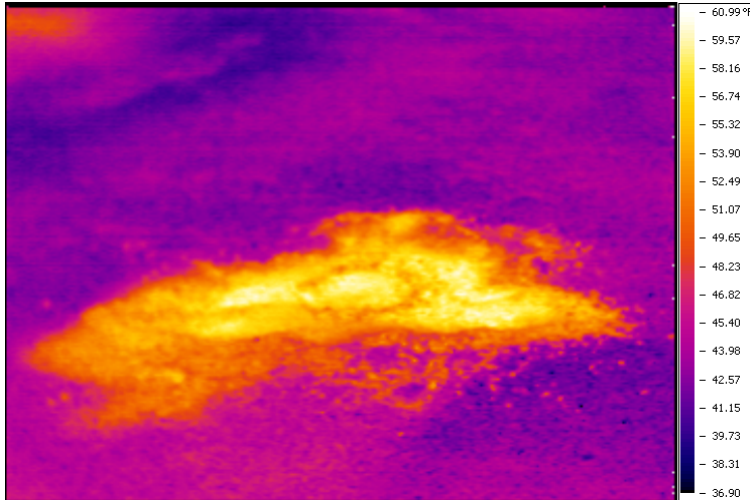
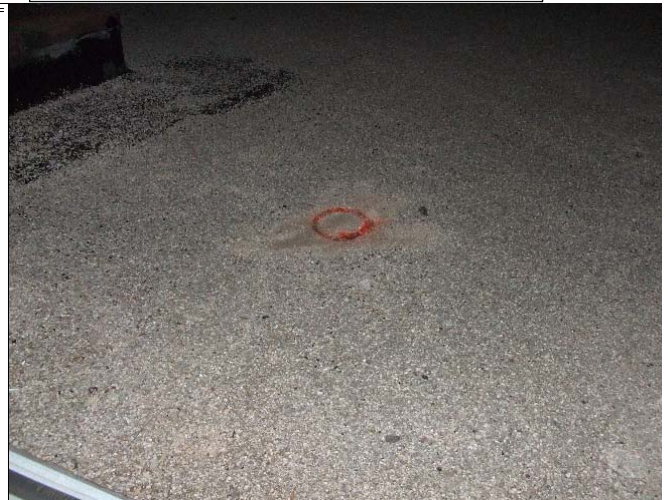
Component: Southeast Side - North side of Old building

Probable Cause: Location showed possible moisture penetration.

Recommendation: Confirm with moisture probe and/or core sample.
