Thermal Problem Detail Report

Site: Russell Reeves Home

Location: Guest Room

Equipment: South Wall

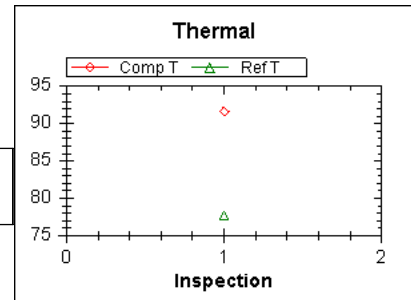
Inspection#: 1	Prob#: 13
Prob Date&Time: 08/24/2008 17:52	
Indirect Temp.Measurement: No	
Component Temp.: 91.7@N/A	
Reference Temp.: 77.7@N/A	
Temp.Rise: 14.0@N/A

Component: South wall.

Probable Cause: Insulation Deficient. Note the bright shaded area near the top of the wall.

Recommendation: Consider upgrading this area with additional insulation, in order to improve efficiency. I recommend an insulation contractor evaluate and estimate costs of installing insulation in this area.
