## Thermal Problem Detail Report

**Site:** Ennis Extruded Products

**Location:** MCC 5

**Equipment:** Section D

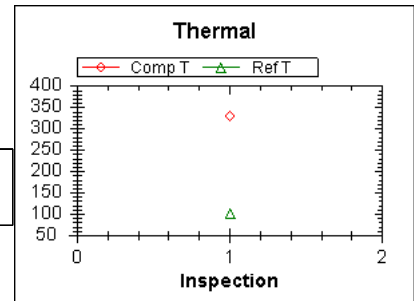
| <b>Component Temp.:</b> 329.7@78.4% | |
| <b>Temp.Rise:</b> 227.8@78.4% | |

**Component:** Section D1 Quincy East - A Phase Fuse Clip

**Probable Cause:** Loose fuse clip on the 'A' phase line side. Also, mismatched fuses.

**Recommendation:** Clean and tighten fuse clip. Replace as necessary.
