## Roof Problem Details Report

**Site:** Campfire USA

**Equipment:** Old Building - North End

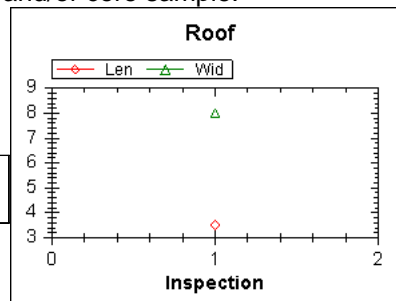
**Component:** Northwest Side - North side of Old building

**Note:** Possible Patch.

**Probable Cause:** Location showed possible moisture penetration.

**Recommendation:** Confirm with moisture probe and/or core sample.

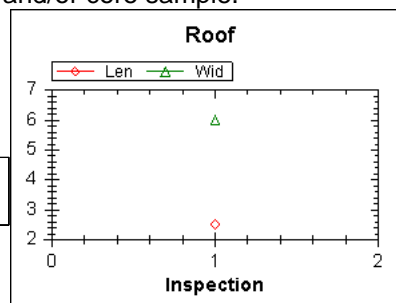
Component: Southeast Side - North side of Old building

Probable Cause: Location showed possible moisture penetration.

Recommendation: Confirm with moisture probe and/or core sample.
